**Flood Control Project Maintenance
Levee Inspections**

Maintenance Issue Types Only, Levee Inspection Report By Mile - Spring 2017

Reclamation District No. 1600 Mull

Waterway	Bank	Unit Miles	Inspection Start/End	Inspector
Unit No. 01 Sacramento River	Right	10.46	04/11/2017 04/11/2017	Zach Jojola

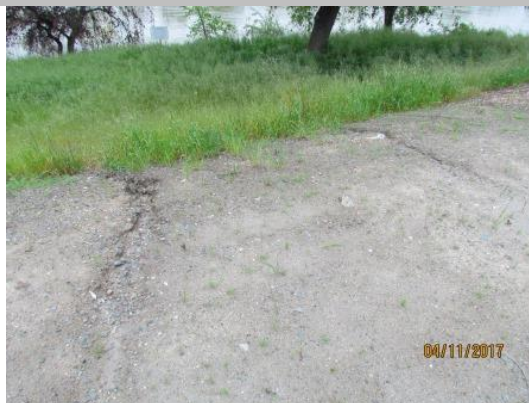
Photo 1 of 1 : SP_2017_RD1600_191_46_20170413_00125.jpg

LM Start	0.12	Rating **	A/W	Issue No.	46
LM End	0.12	Issue Type +	Ma	Location *	WS
Category	Earthen Levee			GPS Latitude/Longitude	
				Start	End
Item	Erosion / Bank Caving			38.676660 °	38.676660 °
				-121.631337 °	-121.631337 °
DWR ID	DWR_RD1600_01_s_2017_46				
Comment Code					
E1 : Note and monitor erosion site.					
Inspector Comment					
Two small rills on waterside levee slope.

Rills from runoff on waterside levee slope. Spring 2017.

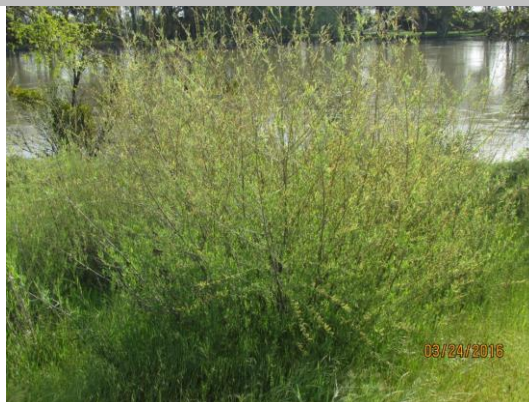
Photo 2 of 3 : SP_2017_RD1600_191_29_20170320_00034.jpg

LM Start	0.60	Rating **	M	Issue No.	29
LM End	0.62	Issue Type +	Ma	Location *	WS
Category	Earthen Levee			GPS Latitude/Longitude	
				Start	End
Item	Vegetation			38.683238 °	38.683415 °
				-121.634388 °	-121.634448 °
DWR ID	DWR_RD1600_01_s_2016_29				
Comment Code					
V2 : Remove the wild growth other than native grasses from the levee slopes.					
Inspector Comment					
Recommend removal of willow trees.

Willows are growing on the waterward side of the levee. Spring 2016.

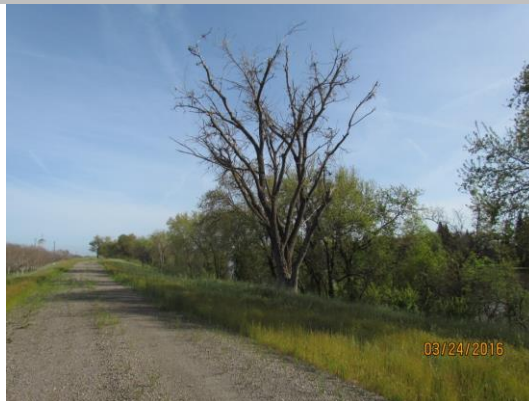
Photo 1 of 2 : SP_2017_RD1600_191_624_20170320_00088.jpg

LM Start	0.78	Rating **	N	Issue No.	624
LM End	0.78	Issue Type +	Ma	Location *	WS
Category	Earthen Levee			GPS Latitude/Longitude	
				Start	End
Item	Trim / Thin Trees			38.685713 °	38.685713 °
				-121.634985 °	-121.634985 °
DWR ID	DWR_RD1600_01_s_2017_624				
Comment Code					
T5 : Tree stumps.					
Inspector Comment					
The tree is dying and needs to be monitored.

View of the dying tree on the waterward side of the levee looking upstream. Spring 2016.

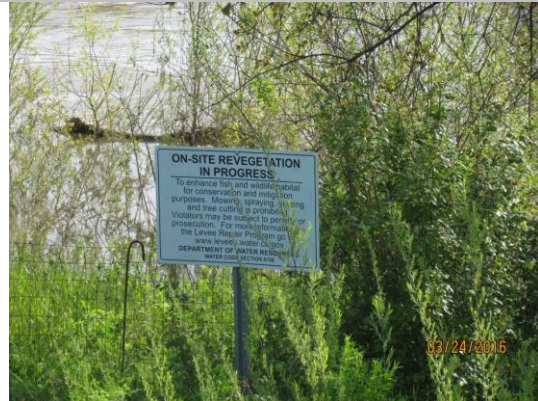
Photo 2 of 2 : SP_2017_RD1600_191_22_20170320_00025.jpg

LM Start	1.01	Rating **	A/W	Issue No.	22 (cont)
LM End	1.10	Issue Type +	Ma	Location *	WS
Category	Earthen Levee			GPS Latitude/Longitude	
				Start	End
Item	Vegetation			38.689092 °	38.690368 °
				-121.635616 °	-121.635669 °
DWR ID	DWR_RD1600_01_s_2012_22				
Comment Code					
V8 : Environmental Requirements.					
Inspector Comment

Sign stating revegetation site. Spring 2016.

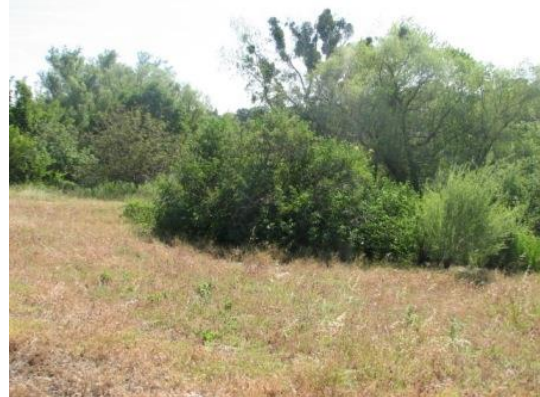
Photo 1 of 2 : SP_2017_RD1600_191_31_20170320_00038.jpg

LM Start	1.72	Rating **	A/W	Issue No.	31
LM End	1.72	Issue Type +	Ma	Location *	WS
Category	Earthen Levee			GPS Latitude/Longitude	
				Start	End
Item	Vegetation			38.698639 °	38.698639 °
				-121.631687 °	-121.631687 °
DWR ID	DWR_RD1600_01_s_2012_31				
Comment Code					
V4 : Elderberries are blocking visibility and flood fight capability.					
Inspector Comment

A photo of a Elderberry bush in the area.

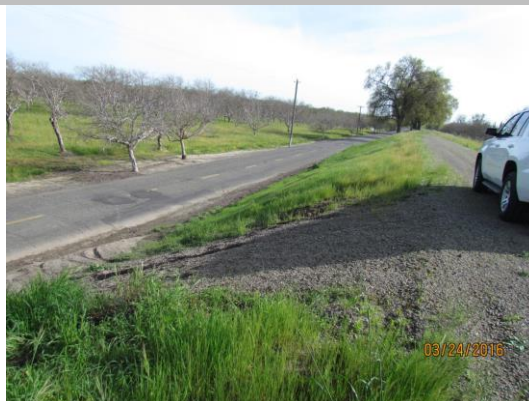
Photo 3 of 4 : SP_2017_RD1600_191_72_20170320_00076.jpg

LM Start	2.01	Rating **	M	Issue No.	72 (cont)
LM End	2.01	Issue Type +	Ma	Location *	LS

Perspective view of the erosion on the landward side of the levee looking upstream. Spring 2016.

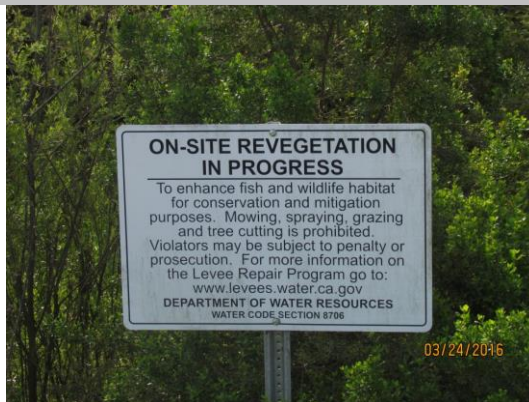
Photo 1 of 2 : SP_2017_RD1600_191_35_20170320_00040.jpg

LM Start	2.35	Rating **	A/W	Issue No.	35
LM End	2.40	Issue Type +	Ma	Location *	WS
Category	Earthen Levee			GPS Latitude/Longitude	
				Start	End
Item	Vegetation			38.704624 °	38.705152 °
				-121.623034 °	-121.622187 °
DWR ID	DWR_RD1600_01_s_2012_35				
Comment Code					
V8 : Environmental Requirements.					
Inspector Comment

Sign for revegetation site. Spring 2016.

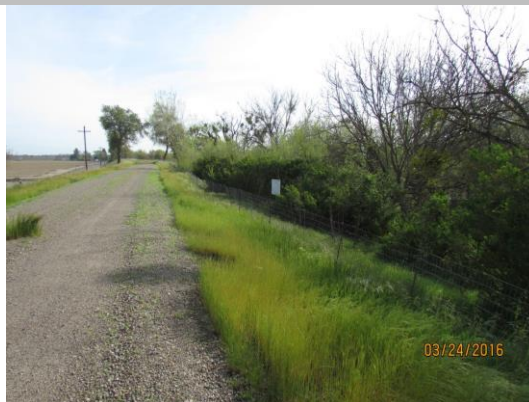
Photo 2 of 2 : SP_2017_RD1600_191_35_20170320_00041.jpg

LM Start	2.35	Rating **	A/W	Issue No.	35 (cont)
LM End	2.40	Issue Type +	Ma	Location *	WS

View of the revegetation site on the waterward side of the levee looking upstream. Spring 2016.

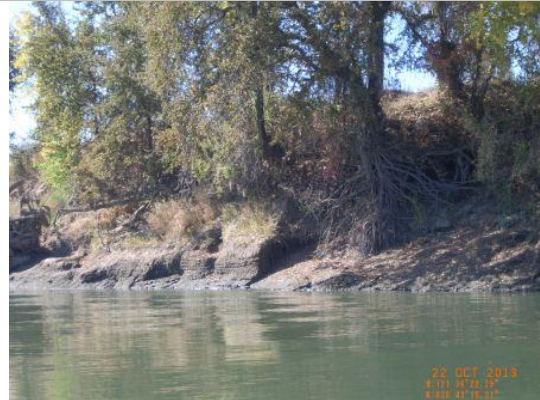
Photo 1 of 1 : SP_2017_RD1600_191_3_20170320_00006.jpg

LM Start	3.58	Rating **	M	Issue No.	3
LM End	3.83	Issue Type +	Ma	Location *	WS
Category	Supplemental			GPS Latitude/Longitude	
				Start	End
Item	2015 USACE Erosion Survey, DRAFT			38.717770 °	38.721351 °
				-121.607423 °	-121.606414 °
DWR ID	DWR_RD1600_01_s_2016_3				
Comment Code					
Inspector Comment					
1997 - Steep high bank. 2005 - Some small pockets in the low toe near the waterline. 2006 - Minor slope clearing. 2010 - Minor new erosion. 2011 - Multiple trees have fallen since last year. Some other trees look ready to fall. Significant new erosion since last year. 2012 - Minor new erosion. 2013 - Minor new erosion. 2015: New minor erosion at toe. [2015 Site ID: SAC_74-4_R]

USACE 2013 Photo #1

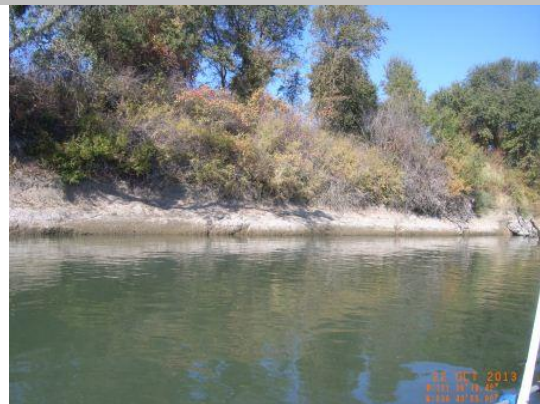
Photo 1 of 1 : SP_2017_RD1600_191_8_20170320_00013.jpg

LM Start	4.34	Rating **	M	Issue No.	8
LM End	4.86	Issue Type +	Ma	Location *	WS
Category	Supplemental			GPS Latitude/Longitude	
				Start	End
Item	2015 USACE Erosion Survey, DRAFT			38.728684 °	38.736110 °
				-121.605844 °	-121.604153 °
DWR ID	DWR_RD1600_01_s_2016_8				
Comment Code					
Inspector Comment					
1997 - Very steep bank. 2005 - Lots of small trees down along the bank at the upstream end. 2006 - Minor new erosion, but slow. 2010 - Almost all of the roots are exposed on the trees, appears ready to fall. 2011 - New erosion and tree popouts. 2012 - Site has become overgrown with vegetation, making it hard to observe. 2015: Dense vegetation made observation difficult. [2015 Site ID: SAC_75-3_R]

USACE 2013 Photo #1

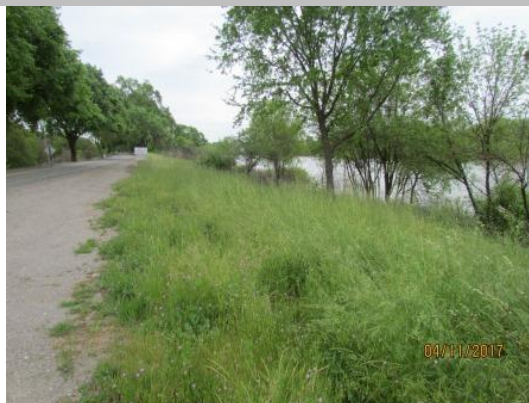
Photo 1 of 1 : SP_2017_RD1600_191_79_20170413_00130.jpg

LM Start	5.86	Rating **	U	Issue No.	79
LM End	7.75	Issue Type +	Ma	Location *	WS
Category	Earthen Levee			GPS Latitude/Longitude	
				Start	End
Item	Vegetation			38.749368 °	38.774944 °
				-121.597175 °	-121.602077 °
DWR ID	DWR_RD1600_01_s_2017_79				
Comment Code					
V1 : Control annual grass and weeds on the levee slopes and easements.					
Inspector Comment

Tall grass on waterside levee slope, blocking visibility. Spring 2017.

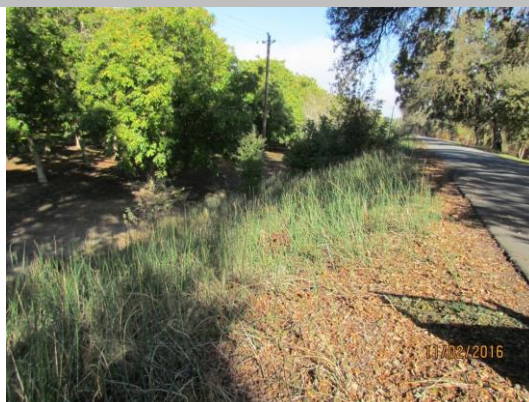
Photo 1 of 1 : SP_2017_RD1600_191_59_20170320_00064.jpg

LM Start	6.00	Rating **	M	Issue No.	59
LM End	6.11	Issue Type +	Ma	Location *	LS
Category	Earthen Levee			GPS Latitude/Longitude	
				Start	End
Item	Vegetation			38.751179 °	38.752670 °
				-121.596173 °	-121.595485 °
DWR ID	DWR_RD1600_01_f_2016_59				
Comment Code					
V2 : Remove the wild growth other than native grasses from the levee slopes.					
Inspector Comment

Vegetation on LS slope partially blocks visibility. Fall 2016.

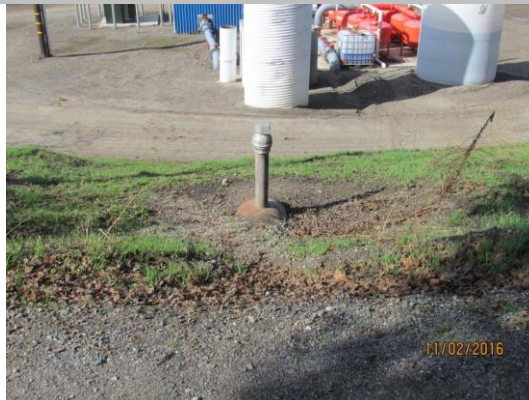
Photo 2 of 2 : SP_2017_RD1600_191_1199_20170320_00098.jpg

LM Start	6.39	Rating **	M	Issue No.	1199 (cont)
LM End	6.39	Issue Type +	Ma	Location *	LS

Updated view of the pipe with syphon breaker. Fall 2016.

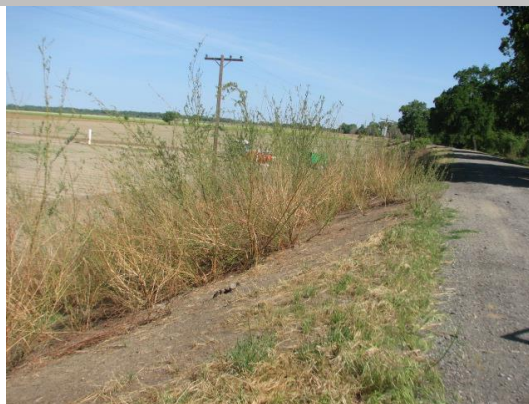
Photo 1 of 2 : SP_2017_RD1600_191_631_20170320_00095.jpg

LM Start	6.60	Rating **	M	Issue No.	631
LM End	6.62	Issue Type +	Ma	Location *	LS
Category	Earthen Levee			GPS Latitude/Longitude	
				Start	End
Item	Vegetation			38.759633 °	38.760013 °
				-121.594128 °	-121.594148 °
DWR ID	DWR_RD1600_01_s_2014_631				
Comment Code					
V2 : Remove the wild growth other than native grasses from the levee slopes.					
Inspector Comment

The tall brush and vegetation blocks visibility. Spring 2014

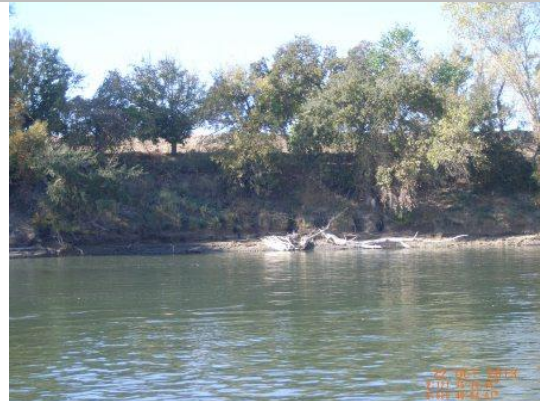
Photo 1 of 1 : SP_2017_RD1600_191_6_20170320_00011.jpg

LM Start	6.95	Rating **	M	Issue No.	6
LM End	6.98	Issue Type +	Ma	Location *	WS
Category	Supplemental			GPS Latitude/Longitude	
				Start	End
Item	2015 USACE Erosion Survey, DRAFT			38.764801 °	38.765219 °
				-121.594926 °	-121.595049 °
DWR ID	DWR_RD1600_01_s _ 2016_6				
Comment Code					
Inspector Comment					
2006 - Eddy scour off end of rock causing erosion and scour hole near levee. Sandy silt bank with rock on upstream end. 2010 - Trees are leaning more, minor new erosion. 2011 - Many of the tree roots have scoured out and trees look ready to fall. 2015: No observed changes. [2015 Site ID: SAC_77-7_R]

USACE 2013 Photo #1

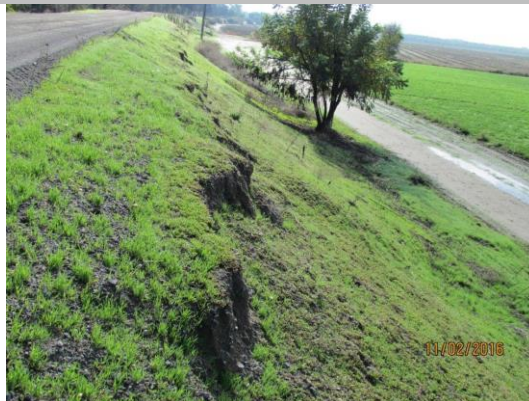
Photo 3 of 3 : SP_2017_RD1600_191_27_20170320_00030.jpg

LM Start	6.97	Rating **	A/W	Issue No.	27 (cont)	
LM End	6.97	Issue Type +	Ma	Location *	LS	
Category	Earthen Levee			GPS Latitude/Longitude		
				Start		End
Item	Erosion / Bank Caving			38.764974 °		38.764974 °
				-121.595533 °		-121.595533 °
DWR ID	DWR_RD1600_01_s_2012_27					
Comment Code						
E1 : Note and monitor erosion site.						
Inspector Comment

Updated view of erosion site. Fall 2016.

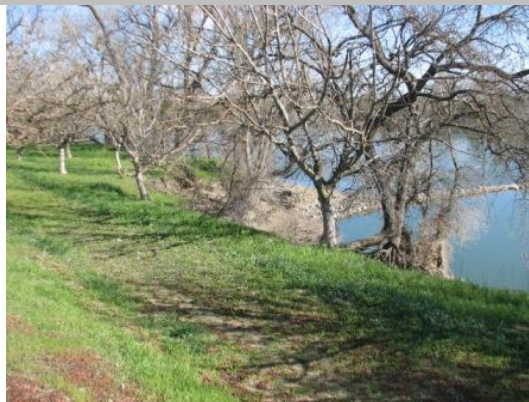
Photo 1 of 2 : SP_2017_RD1600_191_30_20170320_00036.jpg

LM Start	6.97	Rating **	A/W	Issue No.	30
LM End	6.97	Issue Type +	Ma	Location *	WS
Category	Earthen Levee			GPS Latitude/Longitude	
				Start	End
Item	Erosion / Bank Caving			38.764980 °	38.764980 °
				-121.595513 °	-121.595513 °
DWR ID	DWR_RD1600_01_s_2013_30				
Comment Code					
E1 : Note and monitor erosion site.					
Inspector Comment

Erosion is into the berm area and needs to be monitored. Spring 2013

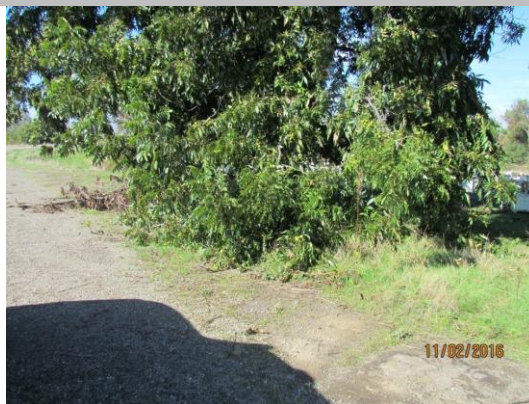
Photo 1 of 1 : SP_2017_RD1600_191_63_20170320_00067.jpg

LM Start	8.18	Rating **	M	Issue No.	63
LM End	8.18	Issue Type +	Ma	Location *	WS
Category	Earthen Levee			GPS Latitude/Longitude	
				Start	End
Item	Trim / Thin Trees			38.778922 °	38.778922 °
				-121.608075 °	-121.608075 °
DWR ID	DWR_RD1600_01_f_2015_63				
Comment Code					
T1 : Trim trees to at least five feet above ground level.					
Inspector Comment

Tree trimming on WS slope is needed. Fall 2016.

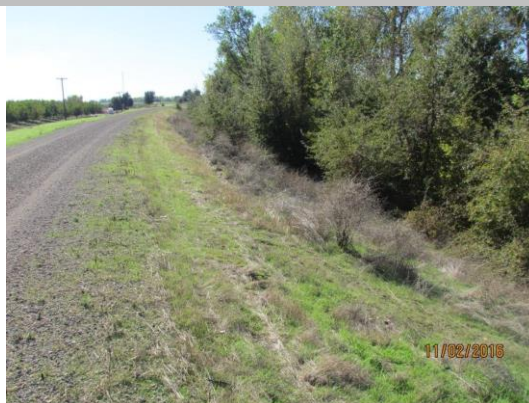
Photo 1 of 1 : SP_2017_RD1600_191_66_20170320_00069.jpg

LM Start	9.40	Rating **	M	Issue No.	66
LM End	10.45	Issue Type +	Ma	Location *	WS
Category	Earthen Levee			GPS Latitude/Longitude	
				Start	End
Item	Vegetation			38.778649 °	38.765406 °
				-121.627172 °	-121.635004 °
DWR ID	DWR_RD1600_01_f_2016_66				
Comment Code					
V2 : Remove the wild growth other than native grasses from the levee slopes.					
Inspector Comment					
Only about 10 ft of WS slope cleared.

Vegetation on WS slope has been cleared only about 10 ft. from the crown. Fall 2016.

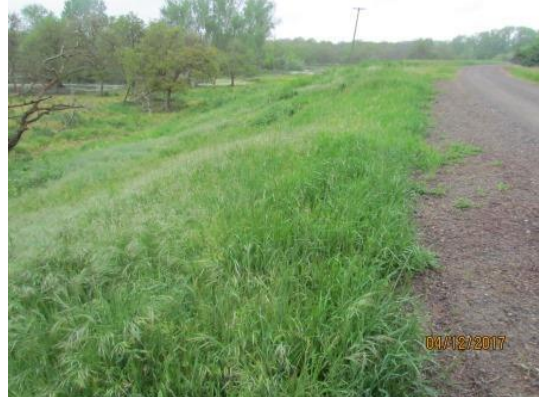
Photo 1 of 1 : SP_2017_RD1600_191_83_20170413_00131.jpg

LM Start	9.53	Rating **	U	Issue No.	83
LM End	9.93	Issue Type +	Ma	Location *	LS
Category	Earthen Levee			GPS Latitude/Longitude	
				Start	End
Item	Vegetation			38.777010 °	38.772388 °
				-121.628252 °	-121.631607 °
DWR ID	DWR_RD1600_01_s_2017_83				
Comment Code					
V1 : Control annual grass and weeds on the levee slopes and easements.					
Inspector Comment

Tall grass on landside levee slope, blocking visibility. Spring 2017.

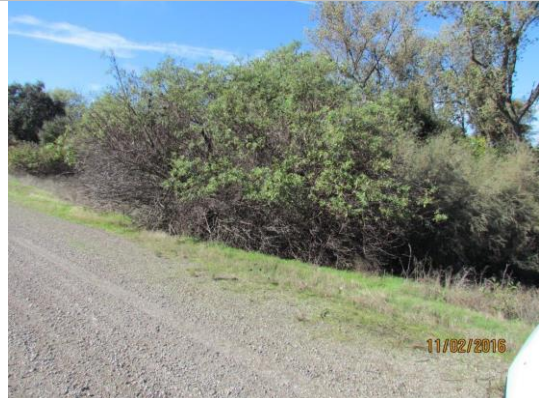
Photo 1 of 1 : SP_2017_RD1600_191_1201_20170320_00100.jpg

LM Start	9.59	Rating **	A/W	Issue No.	1201
LM End	9.59	Issue Type +	Ma	Location *	WS
Category	Earthen Levee			GPS Latitude/Longitude	
				Start	End
Item	Vegetation			38.776493 °	38.776493 °
				-121.629160 °	-121.629160 °
DWR ID	DWR_RD1600_01_s_2015_1201				
Comment Code					
V4 : Elderberries are blocking visibility and flood fight capability.					
Inspector Comment

Elderberry tree on WS slope. Fall 2016.

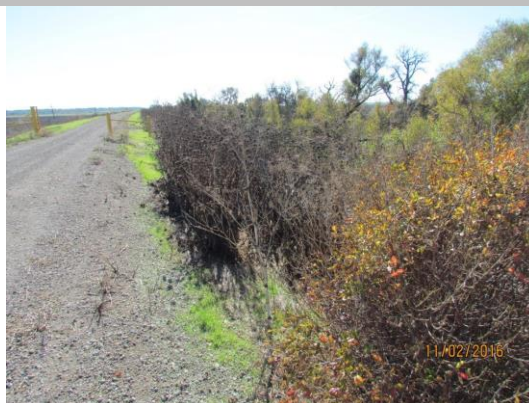
Photo 1 of 1 : SP_2017_RD1600_192_5_20170320_00004.jpg

LM Start	0.39	Rating **	M	Issue No.	5
LM End	0.91	Issue Type +	Ma	Location *	WS
Category	Earthen Levee			GPS Latitude/Longitude	
				Start	End
Item	Vegetation			38.730547 °	38.723081 °
				-121.633490 °	-121.633449 °
DWR ID	DWR_RD1600_02_f_2016_5				
Comment Code					
V2 : Remove the wild growth other than native grasses from the levee slopes.					
Inspector Comment

View of vegetation on waterside slope. Fall 2016.

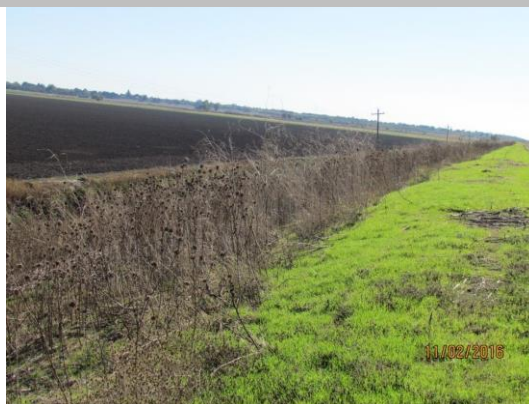
Photo 1 of 1 : SP_2017_RD1600_192_7_20170320_00007.jpg

LM Start	0.41	Rating **	A/W	Issue No.	7
LM End	1.01	Issue Type +	Ma	Location *	LS
Category	Earthen Levee			GPS Latitude/Longitude	
				Start	End
Item	Vegetation			38.730316 °	38.721685 °
				-121.633472 °	-121.633577 °
DWR ID	DWR_RD1600_02_f_2016_7				
Comment Code					
V2 : Remove the wild growth other than native grasses from the levee slopes.					
Inspector Comment

View of vegetation on landside slope. Fall 2016.

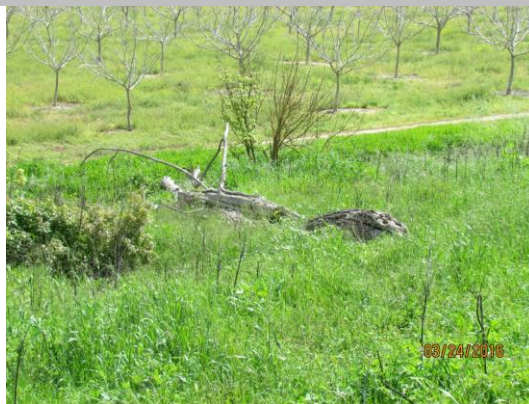
Photo 1 of 2 : SP_2017_RD1600_192_2_20170320_00001.jpg

LM Start	2.40	Rating **	M	Issue No.	2	
LM End	2.40	Issue Type +	Ma	Location *	LS	
Category	Earthen Levee			GPS Latitude/Longitude		
				Start		End
Item	Encroachments			38.702366 °		38.702366 °
				-121.640732 °		-121.640732 °
DWR ID	DWR_RD1600_02_s_2016_2					
Comment Code						
TR : Tree or limb						
Inspector Comment

A tree has fallen on the landward side of the levee. Spring 2016.

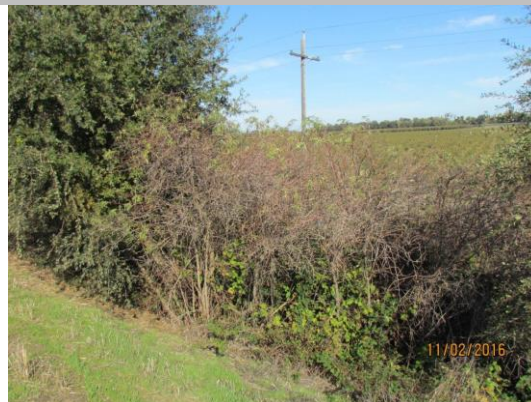
Photo 1 of 1 : SP_2017_RD1600_192_299_20170320_00019.jpg

LM Start	3.53	Rating **	A/W	Issue No.	299
LM End	3.53	Issue Type +	Ma	Location *	LS
Category	Earthen Levee			GPS Latitude/Longitude	
				Start	End
Item	Vegetation			38.686436 °	38.686436 °
				-121.644799 °	-121.644799 °
DWR ID	DWR_RD1600_02_s_2015_299				
Comment Code					
V4 : Elderberries are blocking visibility and flood fight capability.					
Inspector Comment

Elderberry tree on landside slope. Fall 2016.

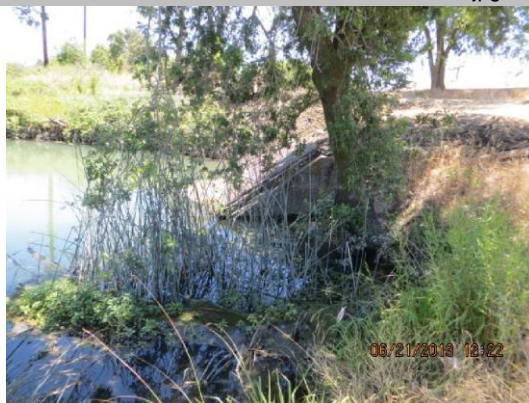
Photo 1 of 3 : UCIP_SP_2017_15303_25158.jpg

LM Start	4.17	Rating **	A/W	Issue No.	302
LM End	4.17	Issue Type +	Ma	Location *	LS
Category	Supplemental			GPS Latitude/Longitude	
				Start	End
Item	DWR UCIP LMA Responsibility			38.677286 °	38.677286 °
				-121.643683 °	-121.643683 °
DWR ID					
Comment Code					
Inspector Comment					
FS_ID:15303 DS_ID:21502 EP_NO: N/A Repair Type: No Action Needed Crossing Status: Found UCIP Comments: FIELD_STRUCT_DESC: 6x6-foot concrete box culvert through the levee 26.0 feet below the crown. Slide gate on the waterward slope in a 9'X10' concrete box. Culvert passes under the bypass canal, the railroad, and county road 22 and terminates in canal on southwest side of road 22 bridge. Originally included in the 1955 O&M manual. FS Date: 6/21/2013

Concrete intake structure on LS.

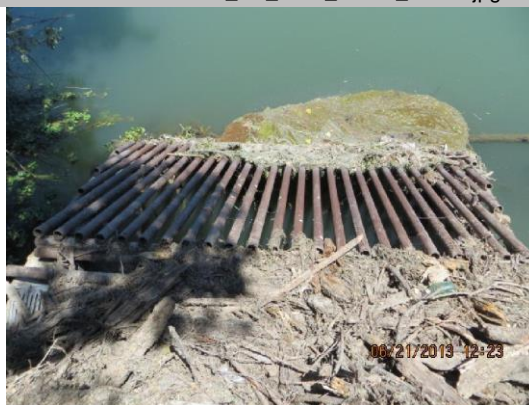
Photo 2 of 3 : UCIP_SP_2017_15303_25157.jpg

Concrete intake structure on LS.

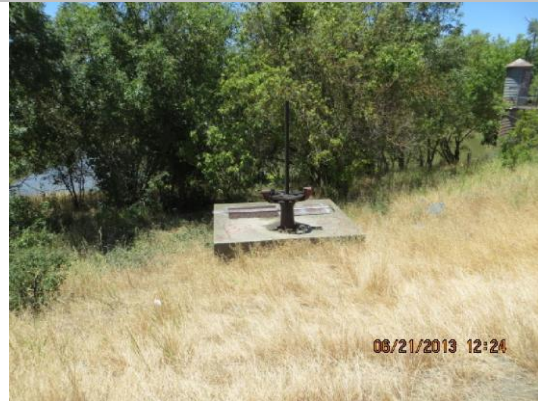
Photo 3 of 3 : UCIP_SP_2017_15303_25156.jpg

LM Start	4.17	Rating **	A/W	Issue No.	302 (cont)	
LM End	4.17	Issue Type +	Ma	Location *	LS	
Category	Supplemental			GPS Latitude/Longitude		
				Start		End
Item	DWR UCIP LMA Responsibility			38.677286 °		38.677286 °
				-121.643683 °		-121.643683 °
DWR ID						
Comment Code						
Inspector Comment						
FS_ID:15303						
DS_ID:21502						
EP_NO: N/A						
Repair Type: No Action Needed						
Crossing Status: Found						
UCIP Comments:						
FIELD_STRUCT_DESC: 6x6-foot concrete box culvert through the						
levee 26.0 feet below the crown. Slide gate on the waterward slope in a						
9'X10' concrete box. Culvert passes under the bypass canal, the						
railroad, and county road 22 and terminates in canal on southwest side						
of road 22 bridge. Originally included in the 1955 O&M manual.						
FS Date: 6/21/2013

Slide gate in 9'X10' concrete box on WS slope.

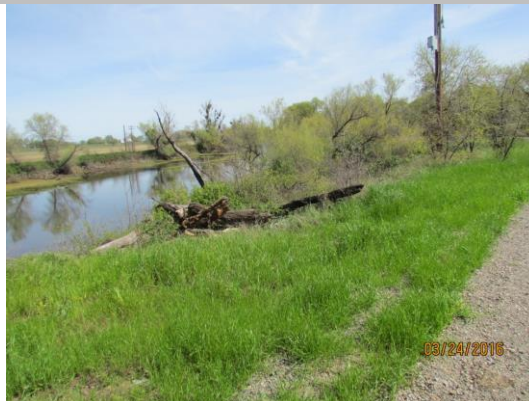
Photo 1 of 2 : SP_2017_RD1600_192_6_20170320_00005.jpg

LM Start	4.19	Rating **	M	Issue No.	6
LM End	4.19	Issue Type +	Ma	Location *	LS
Category	Earthen Levee			GPS Latitude/Longitude	
				Start	End
Item	Encroachments			38.677121 °	38.677121 °
				-121.643466 °	-121.643466 °
DWR ID	DWR_RD1600_02_s_2016_6				
Comment Code					
PR : Prunings					
Inspector Comment

View of the trees on the landward side of the levee looking downstream. Spring 2016.

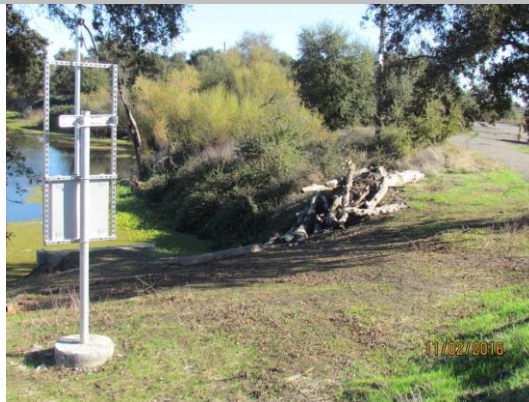
Photo 2 of 2 : SP_2017_RD1600_192_6_20170320_00006.jpg

View of debris on LS slope. Fall 2016.
